## Inverness North

### Façade Condition Assessment Report

**SUBJECT:** **Façade Condition Assessment Report – Rev. 1**  
Inverness North  
Potomac, MD 20854  
BECS #20230013

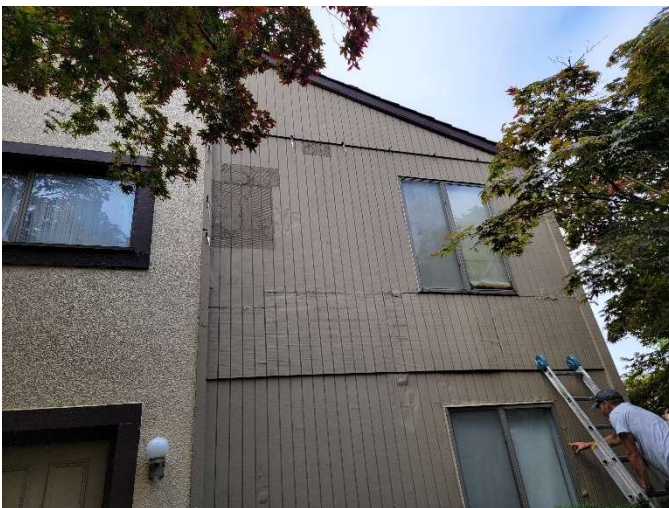
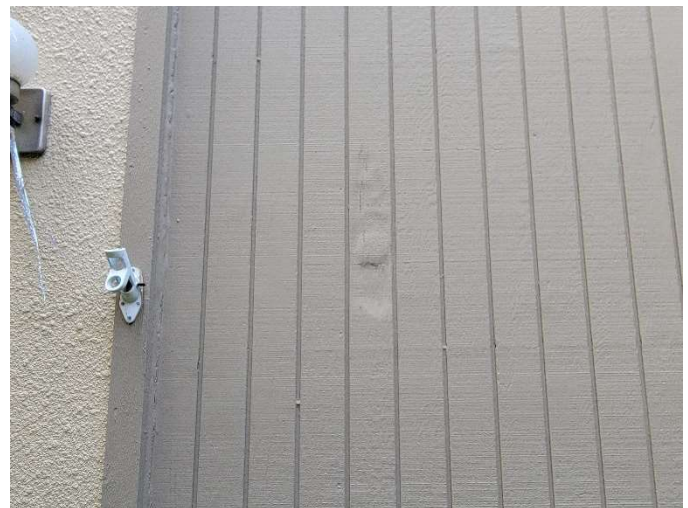
A *significant* percentage of the exterior T1-11 wood panels around the buildings are visibly decayed, to varying degrees. Although the deteriorated areas are often covered with paint, it is apparent the “wavy” or “bubbled” areas of the panels are rotted through. We were able to penetrate with a screwdriver through the T1-11 panels with little resistance at these locations. Near the base, the bottom edge of the T1-11 panels wick water upward, accelerating deterioration where the water doesn’t simply shed off the edge.

**Photos 1 & 2: Wood T1-11 siding, visually bubbled/wavy where deteriorated.**

***BECS recommends fully re-siding townhomes which have signs of deterioration. This work can be phased so that costs and disruption to the community are more manageable. Based on our visual survey, the siding at units identified with severe deterioration are recommended to be replaced within the next 1-2 years, and townhomes which have limited deterioration within the next 2-5 years. Remaining units should be monitored for degradation over time.***

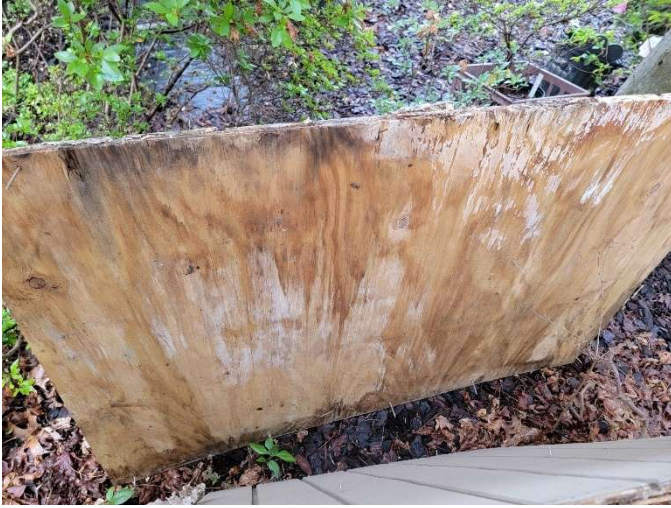
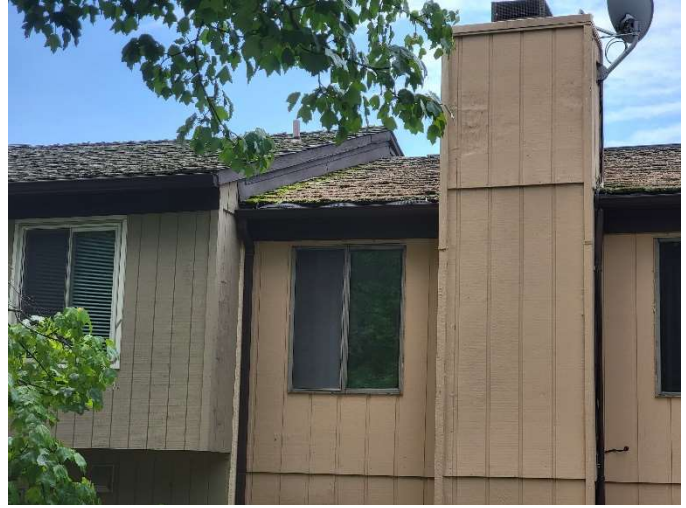
**Photo 3 & 4: Wood T1-11 siding stained on back side. Severe deterioration at chimney**

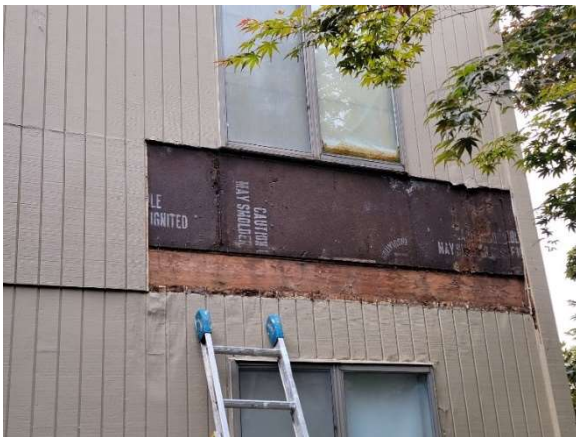
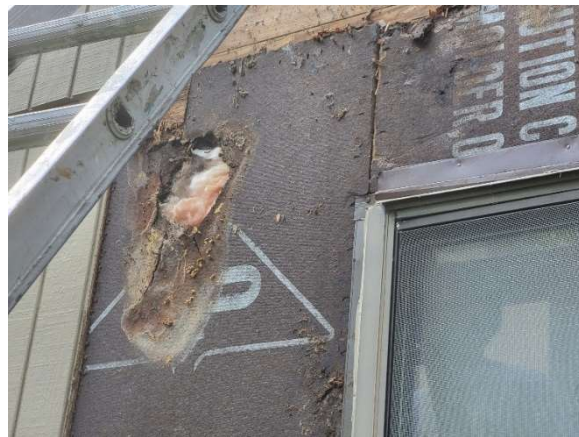
Despite having an inherent water-resistant quality, the black asphaltic fiberboard sheathing is not intended to provide a waterproof barrier for the structure. The fiberboard sheathing is not continuous between floor lines and is not taped or flashed at seams or windows. Additionally, the sheathing is not continuous across floor lines, and leaves the wood structural framing directly exposed to the rear face of the T1-11 siding.

**Photos 5 & 6: Wood framing exposed at floor line. Deteriorated fiberboard sheathing.**

2. Remove existing T1-11 siding panels and install a new Air and Weather Barrier on top of existing fiberboard sheathing. This will keep water and moisture from penetrating the wood framing and prevent ongoing deterioration. A new synthetic façade would be installed to cover the AWB. *New windows and doors with full-perimeter flanges are recommended for full weather protection.*

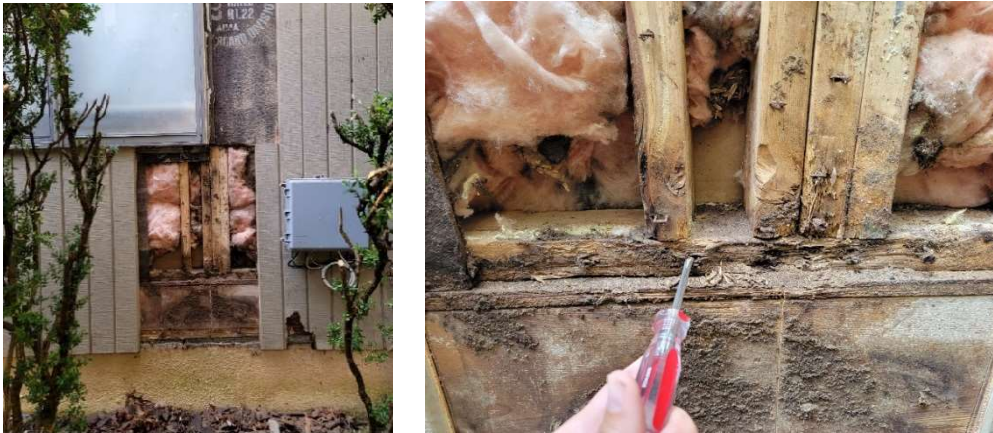
It is evident that water has been penetrating through the top and bottom edges of the window frames, and along the sides, causing staining and some deterioration of the structural wood framing. Some of the wood is rotted at the base of the wall, and around the perimeter of the window frame where there is no flashing. At a minimum, the deteriorated elements should be replaced or reinforced with new framing elements, including studs, plates, and headers. Removing the existing T1-11 siding panels will provide the opportunity to assess the condition of the underlying fiberboard sheathing, and the structural elements.

**Photos 7 & 8: Deteriorated wood framing at base of wall, below window.**

**By removing the paneling at each townhouse we would be able to assess the condition of the existing fiberboard and structural framing at each location, and ensure structural repairs are completed where necessary.**
